iRADVC7000/9000s

- 1.Coating error
- 2.Coating failure at rear side of sleeve
- 3.Toner leaking

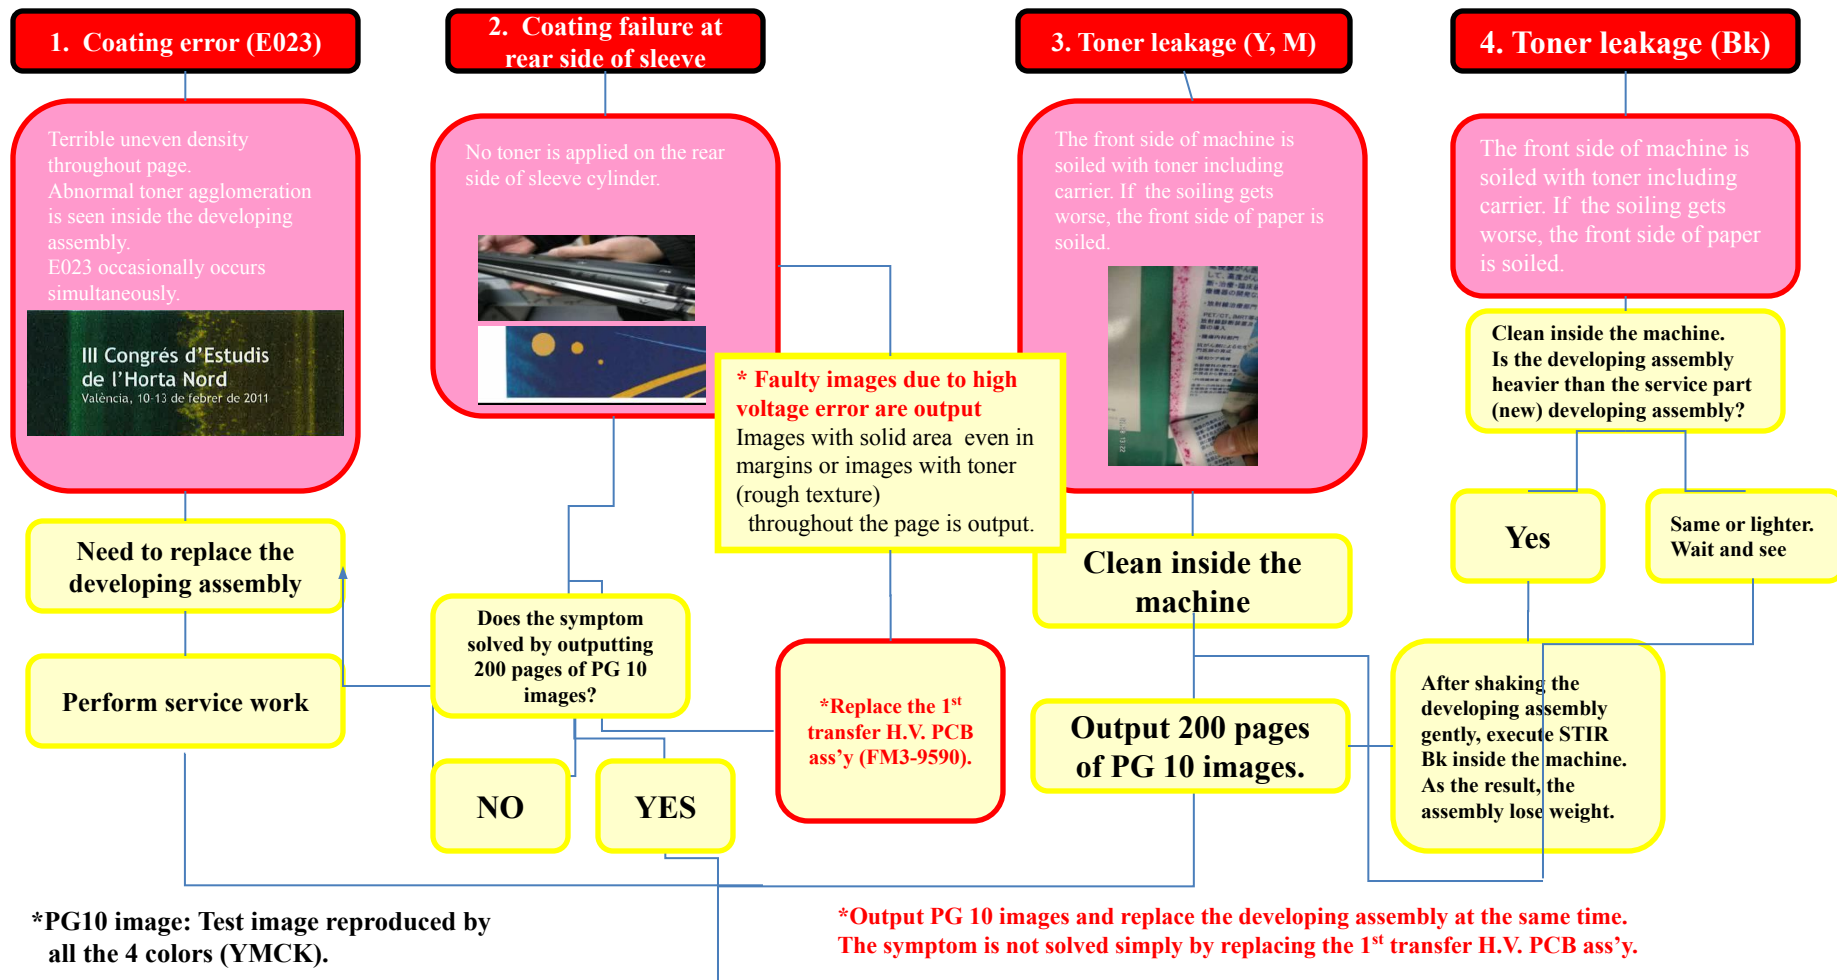
Service work: Workflow

A. Temperature rise inside of the machine

The fluidity of toner inside the developing assembly deteriorates.

This prevents the smooth circulation of toner, and causing toner to tend to remain unmoving inside the developing assembly.

B. Error in servicing

At the time of replacing the developing assembly, the initialization is performed.

But, a used developing assembly is used for this work.

A. As the measure against the temperature rise inside the machine, place the machine far away from the wall as much as possible, and replace the 3 filters regularly.

- Distance between the rear side of machine and the wall: preferably 10cm or more
- Filter (3 filters) replacement intervals: every 500K images

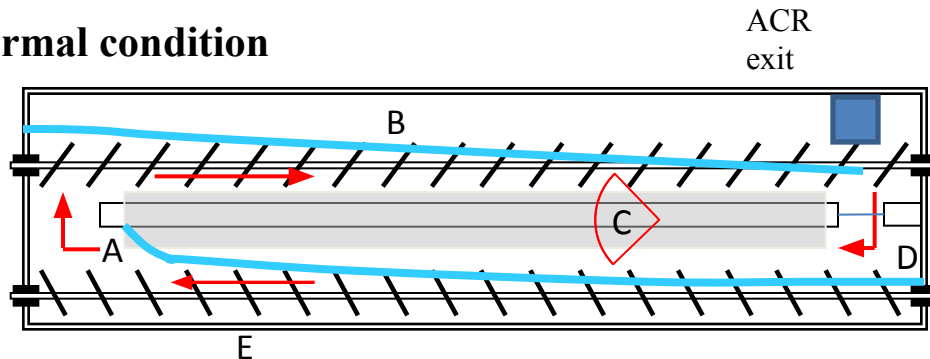
1. Normal condition

If the developer circulation is normal, the developer exists in the distribution shown in the **dotted line**.

Toner flows as the **arrows** show.

A: Pump from bottom up.

B: Being delivered from front to rear.

C: A portion drops according to the sleeve cylinder.

D: Drops.

E: Being delivered from rear to front.

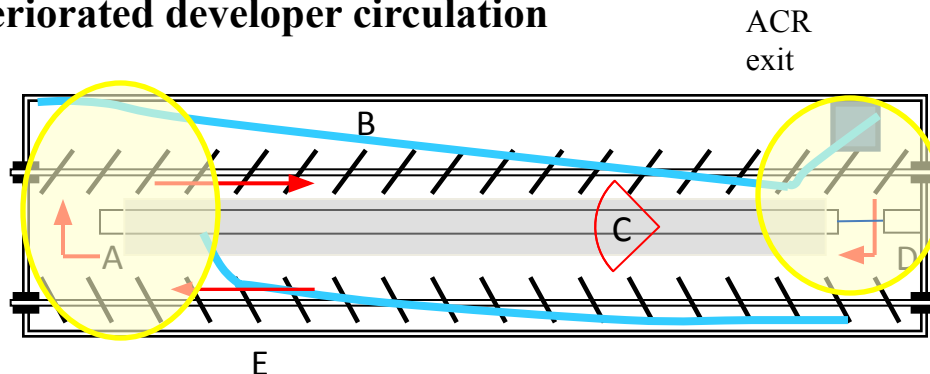
2. Deteriorated developer circulation

If the developer circulation is deteriorated, the developer exists in the distribution shown in the **dotted line**.

Poor developer flow tends to occur at 2 points.

Front/A-B front: Developer accumulates and hardly flows.

Rear/D: Developer accumulates and hardly drops.

-If developer remains unmoving in the front/A-B front side, developer leakage at the front or developer leakage due to increased amount of toner may occur.

-If developer remains unmoving in the rear (D) side, excess developer is discharged, and the amount of toner inside the developing assembly may decrease.
